HARMAN'S FARM POND DAM

MO 30150

PHASE 1 INSPECTION REPORT
NATIONAL DAM SAFETY INSPECTION

MAY 1980

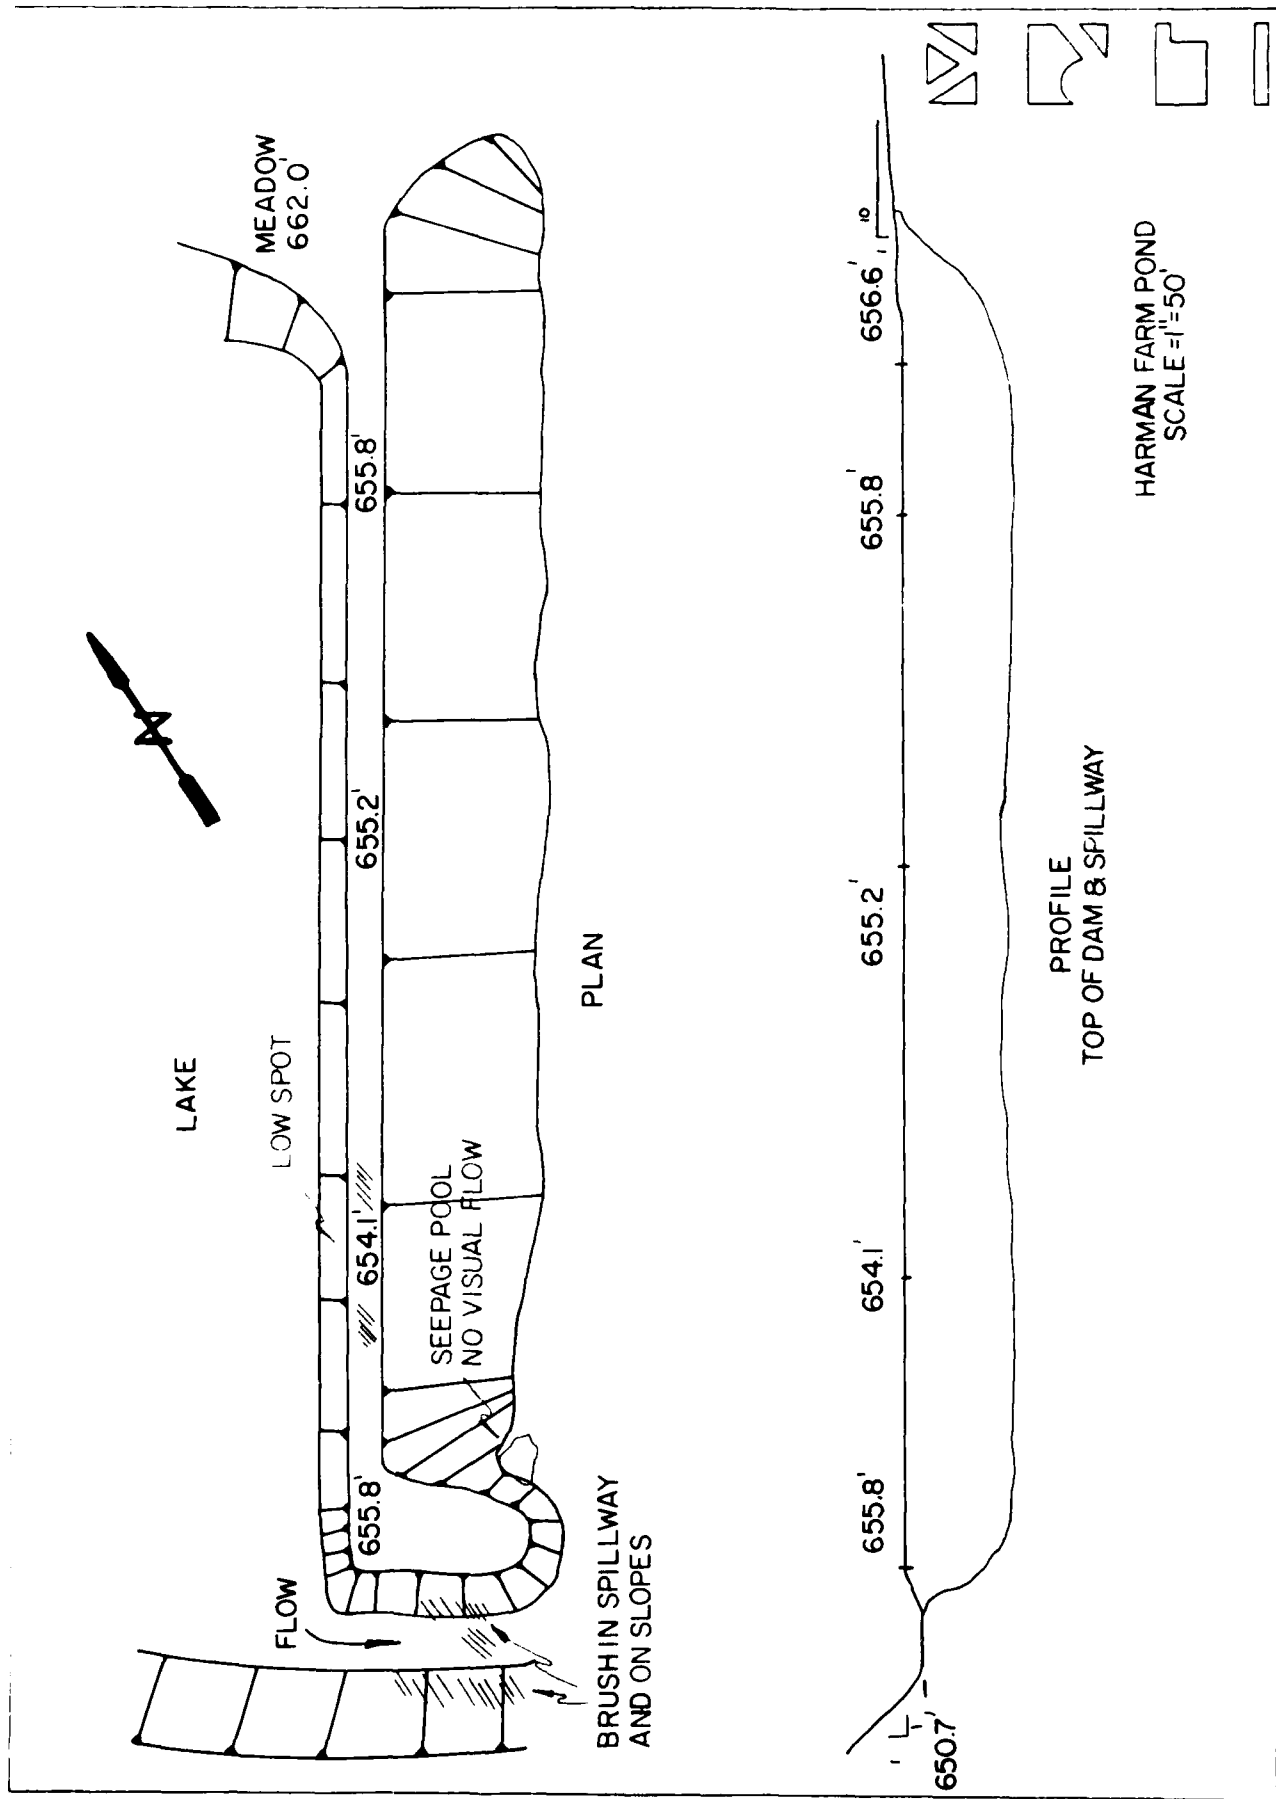
From a brief survey conducted during the inspection, it was determined that a low point on the dam is at elevation 654.1. The earth embankment section of the dam generally rises from the spillway section toward the left abutment. The earth embankment section is 342 feet long with a maximum height of approximately 31.5 feet. The upstream slope varies from 2.5H:1V to 3H:1V. The crest width is approximately 10 feet. The downstream slope is approximately 2.5H:1V. The downstream slope is covered with tall grass, weeds, briars and small trees. No seepage or erosion was noted on the downstream slope although two burrows were seen as well as a small water pool at the toe of the embankment. No discharge was visible from the pool during the inspection (See Figure 1 for location).

3.2 EVALUATION. The visual inspection did not reveal any immediate signs of instability. The earth embankment appears to be in fair condition. Both the upstream and downstream slopes are moderate and vegetated. No visible erosion exists and no seepage was noted although a small pond was present at the toe of the dam (See Figure 1). No discharge was detected from the ponded water.

a. Visual Observations. Visual observations indicate that the dam was in fair condition. No erosion or seepage was noted on the embankment during the inspection. The embankment slopes are moderate and covered with grasses. Ponded water was present at the toe near the right abutment (See Figure 1).

4. Positive drainage should be provided to eliminate the ponded water at the toe of the dam. If the seepage exists, it should be monitored at regular intervals and checked for turbidity (uncontrolled seepage can lead to a piping condition which could result in failure of the dam).
